Case Study

Management & monitoring of an ICOLL entrance clearance

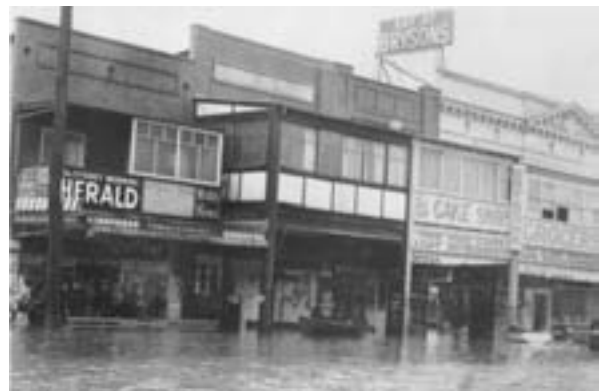
Ocean Street Bridge and causeway. Built in 1928.
Upgraded to concrete in the 1960s.

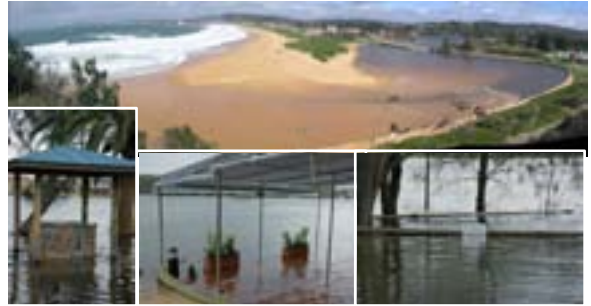
Composite photo of the Narrabeen Lagoon Entrance and photos of flooding in lagoon (September 2006).

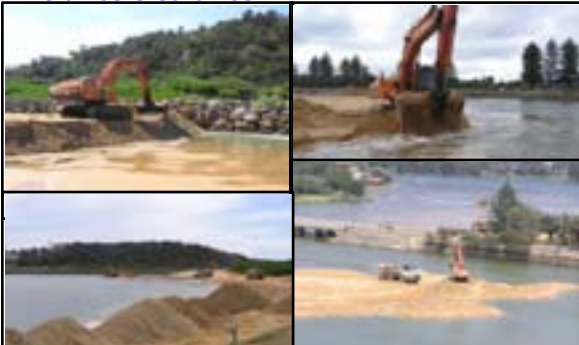
Entrance clearance commenced 29 September 2006

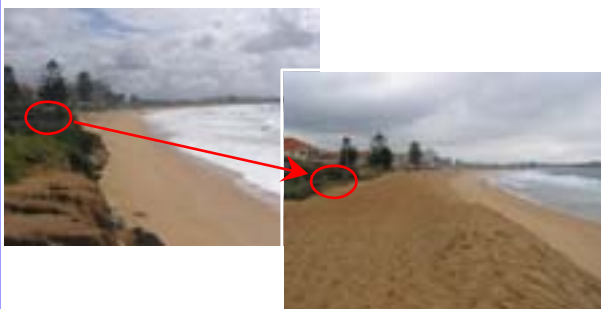
Collaroy/Narrabeen Beach before (left) and after (right) replenishment.
View from Wet herill St looking North.

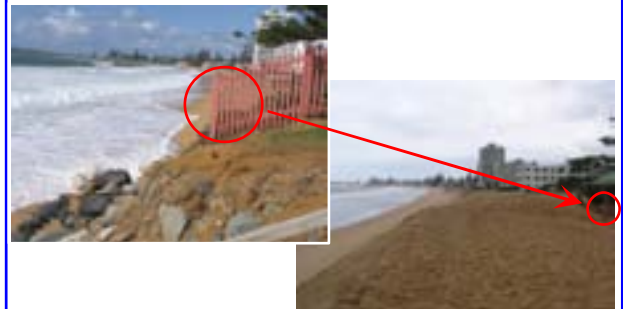
Collaroy/Narrabeen Beach before (left) and after (right) replenishment.
View from Wet herill St looking South.

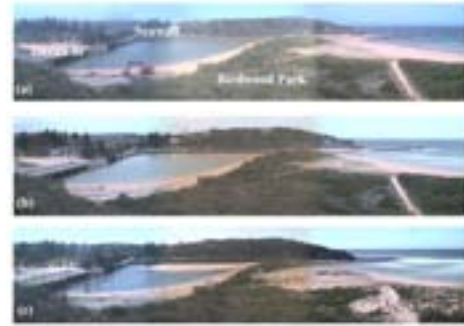
Merged oblique Argus images of the study site

- (a) At the completion of entrance clearance, one day after re-opening the entrance (7 Dec 2006).
- (b) Two months after re-opening (8 Feb 2007).
- (c) Seven months after the re-opening of the entrance (12 Jul 2007).

- video data showed rapid reformation and growth of the flood shoal due to sediment ingress following the re-opening of the lagoon entrance

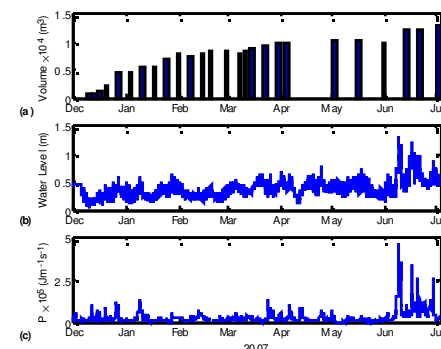
Comparison of volumetric evolution with hydrodynamic forcing.

- (a) Cumulative volume of flood shoal.
- (b) Lagoon water levels.
- (c) Wave power.

- Using morphological maps generated from survey data, the evolution of the volume of the flood shoal was calculated.

- Flood shoal started to form within the first weeks following the entrance clearance.
- Volume shows a consistent increase over time, but is somewhat episodic with changes between surveys being as much as 2,300 m³ (1-14 June 2007), but more typically of the order of 420 m³.
- Total change in volume of the flood shoal in the initial seven months was 12,900 m³, which equates to an average ingress rate of 445 m³/week.
